# Manhole Inspection Summary

Manhole # S33EE1009MH

Insp Date: **3/10/07 9:40 AM**

**Location** Address: **3807 HADLEY SQ**

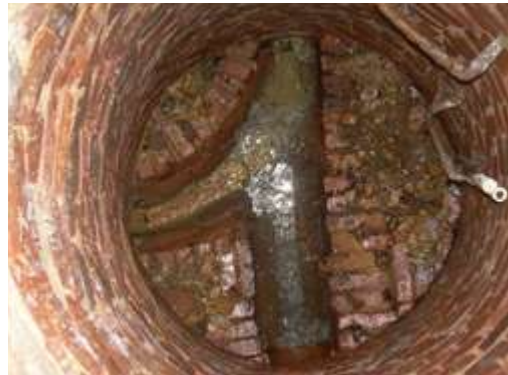
Top View

Corroded steps. Bench deterioration and debris.

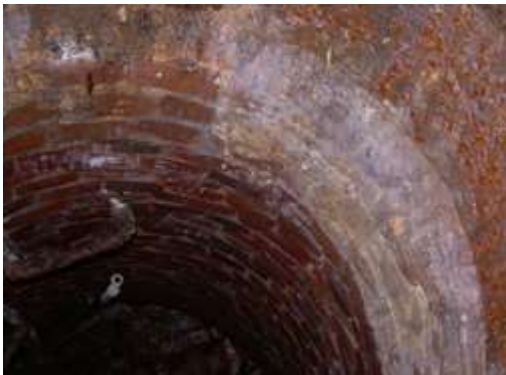
Defect

Corbel infiltration.

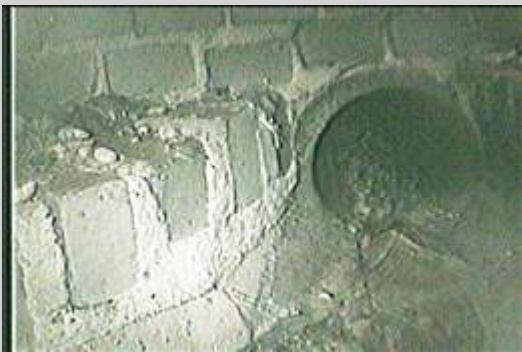
### 8 in. Circular Gravity Sewer Pipe Out @ 12 O'Clock

Infiltration: **None** Pipe Seal Cond: **Unknown**

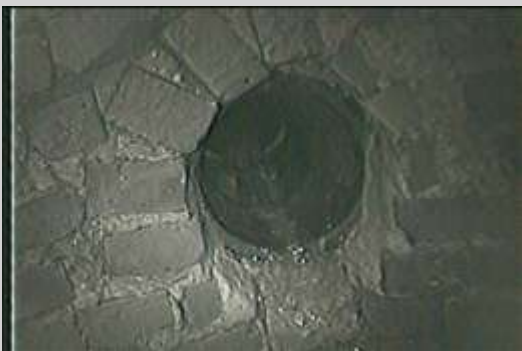
### 8 in. Circular Gravity Sewer Pipe In @ 6 O'Clock

Infiltration: **Evidence** Pipe Seal Cond: **Broken**

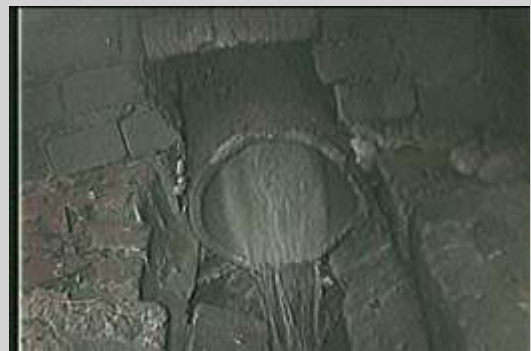
### Drop In @ 6 O'Clock

Barrel deterioration and infiltration. Channel deterioration.

Drop Condition: **Partly Clogged**

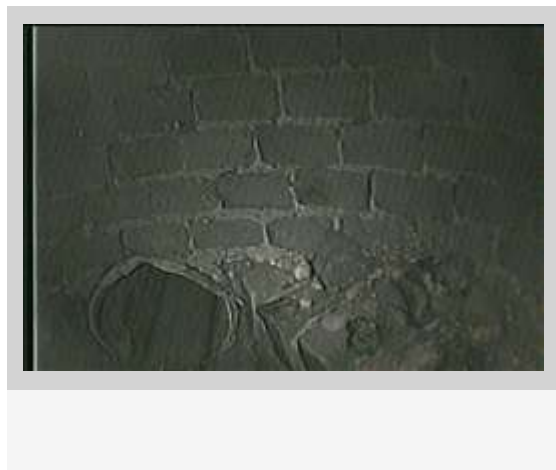
Pipe In @ 9 O'Clock

Infiltration: **Evidence**
